# Picnic Table Repair Overview

PHOTOS AND TEXT: WILLIAM RAU  
RENDERING: INDRA SISWANTO

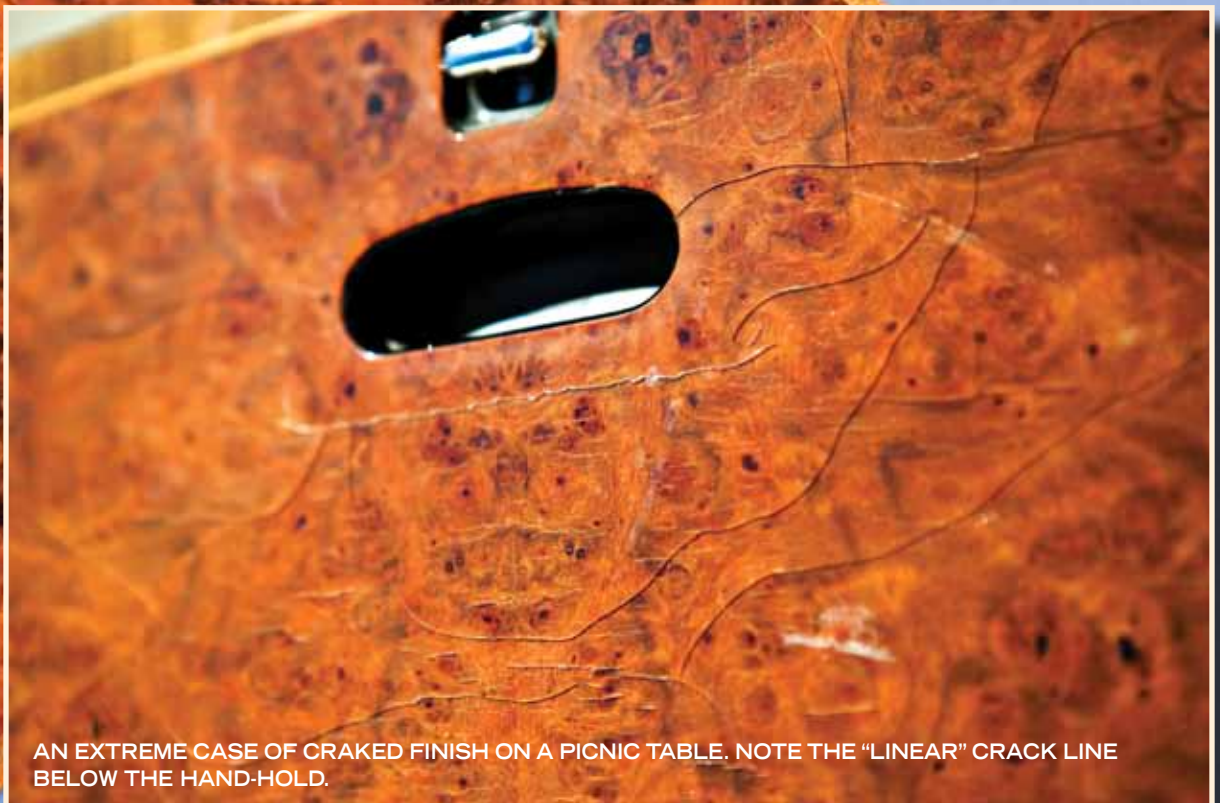
Cracks and fissures too numerous to count, populated the surfaces of too many tables. The most common fault lines emanated from the inserted wood handhold buried under the veneer. (Its attachment would prove to be a contributing factor to the problem.)

AN EXTREME CASE OF CRAKED FINISH ON A PICNIC TABLE. NOTE THE "LINEAR" CRACK LINE BELOW THE HAND-HOLD.

If we don't do something to "fix" the structure of the tables they will "act" as they have in the past and crack the new finish.

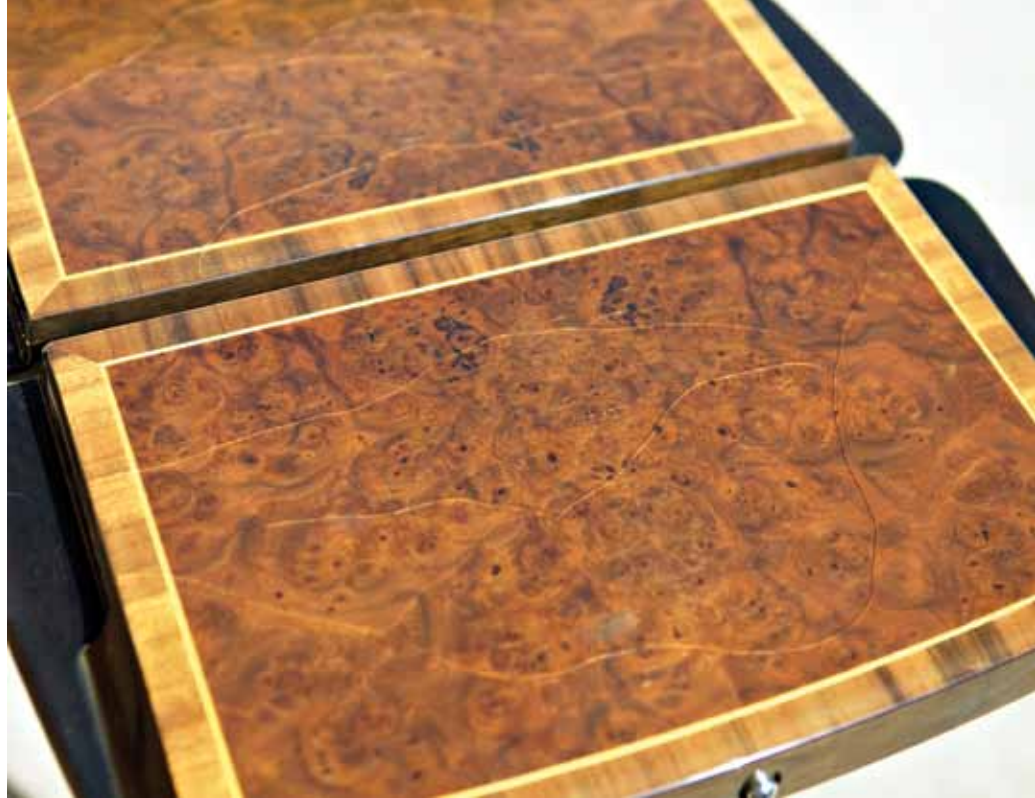
In some cases it was necessary to re-veneer the tables. This revealed a little more of the construction of a factory table. Below the decorative walnut burl veneer was a sub-ve-

THE RAZOR BLADES AND PENCIL SHOW SOME OF THE AREAS THAT HAD POOR ADHESION BETWEEN THE SUB-VENEER AND PLYWOOD.

First, this process saturates the pores of the veneer not with a finishing primer but with a premium industrial adhesive and, secondly, renews the all important bond of the veneer to the substrate. It's impossible to determine all of the minute areas where the veneer has weak or no adhesion to the substrate, so the beauty of this process is that it addresses the entire face of the tables (or other parts) under vacuum pressure.

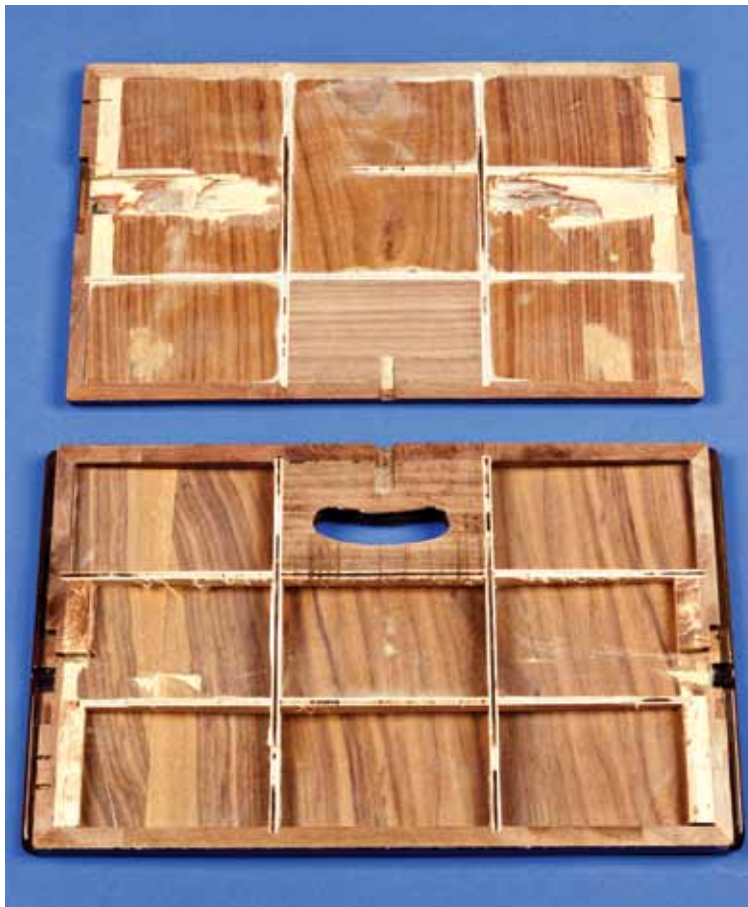
The exploratory surgery was revealing. The frame was solid walnut (similar to earlier tables) but the interior was mostly hollow, with thin plywood stringing, trying to support the space between the front and the back of the table. The front and back themselves were thin plywood, designed somewhat like a soundboard that moves and vibrates. Not the most stable sub-

As you can see from the open table, the interior of the tables was effectively hollow with 8 interior chambers.

INSIDE OF A SPUR PICNIC TABLE WITH 8 CHAMBERS AND INSERTED HAND-HOLD.

Stability is absolutely critical to the longevity of modern catalyzed finishes. There are many factors that can affect these high build topcoats but a stable base is essential. To minimize the movement in these tables and to improve the stability of the faces; we developed a core treatment program that involves a number of proprietary steps and materials to achieve these goals. The treatment anchors the various components of the interior into a single stable element.

Going a little further, injecting high density foam into the tables has the benefit of tying the skins together, and having them work effectively as a tension member

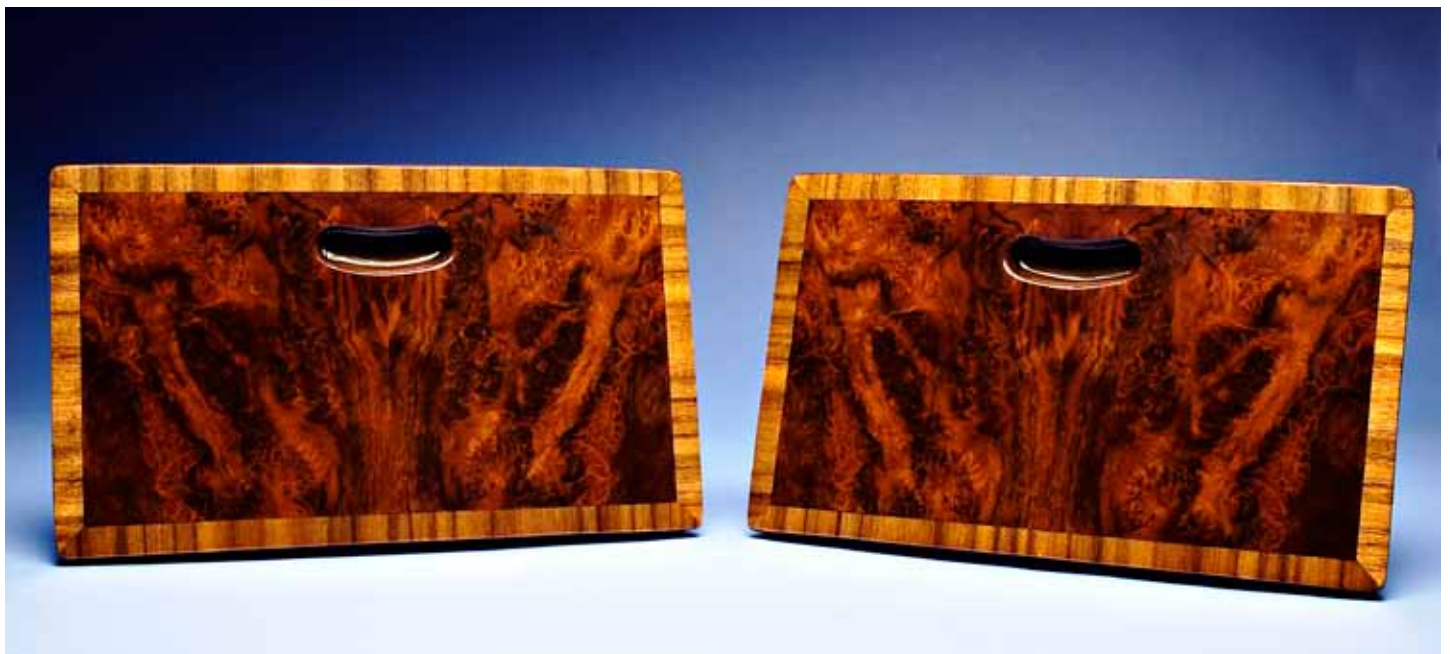
**THE END RESULT: SILVER SPUR PICNIC TABLES: REBUILD, NEW VENEER, FINISH**

Combined, these two procedures demonstrably improve the technical stability of the tables and help to improve the basic construction of the tables producing a more stable part for the final finish.
